10.0 Lowman, Idaho, Disposal Site

10.1 Compliance Summary

The site, located approximately one-half mile northeast of Lowman, Idaho, was inspected on July 8, 2008. Results of the inspection are described below. Features and photograph locations (PLs) mentioned in this report are shown on Figure 10–1. Numbers in the left margin of this report refer to items summarized in the “Executive Summary” table.

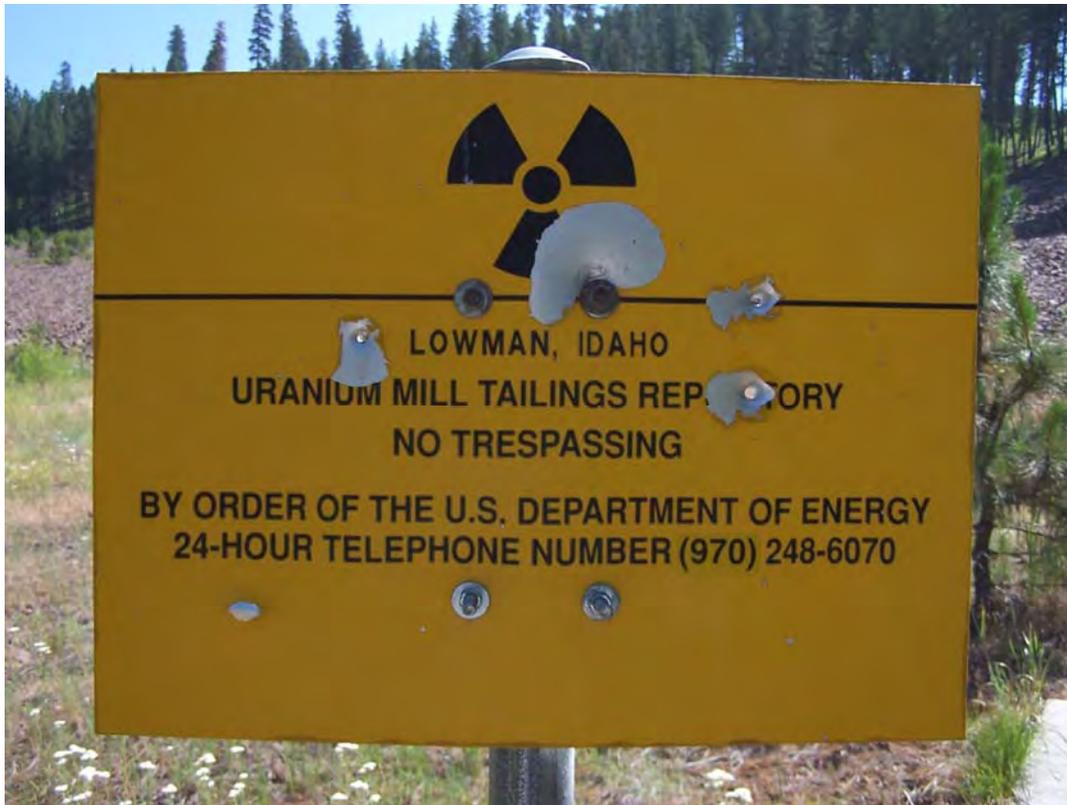
One entrance sign and 18 perimeter signs delineate the unfenced site boundary. The entrance sign is just inside the site boundary near site marker SMK-1. Although the sign has several bullet holes, it was still legible and does not need to be replaced (PL-1). The 18 perimeter signs are on steel posts along the site boundary. Four signs have bullet holes or dents, but they were legible and do not need to be replaced. The other perimeter signs were in excellent condition.

LOW 7/2008. PL-1. Bullet-damaged entrance sign.

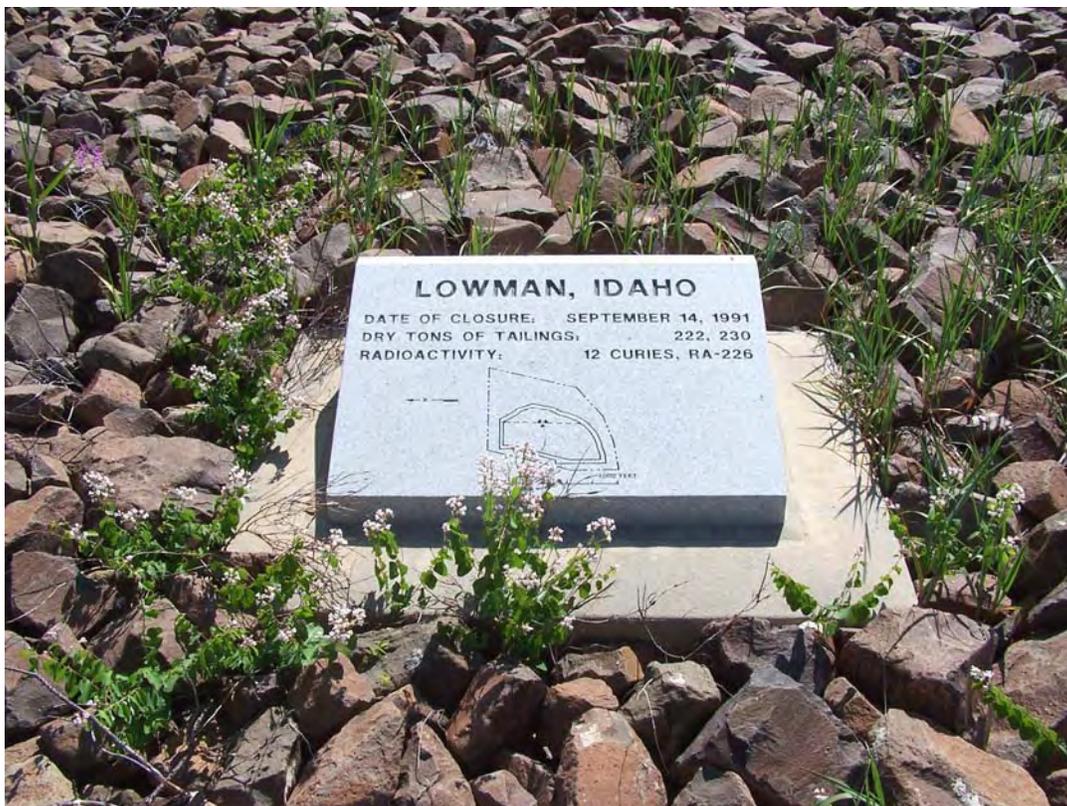
Site Markers and Monuments—There are two site markers (PL-2), four boundary monuments, and three combination survey/boundary monuments. All were in excellent condition.

LOW 7/2008. PL-2. Site marker SMK-2 on the disposal cell cover.

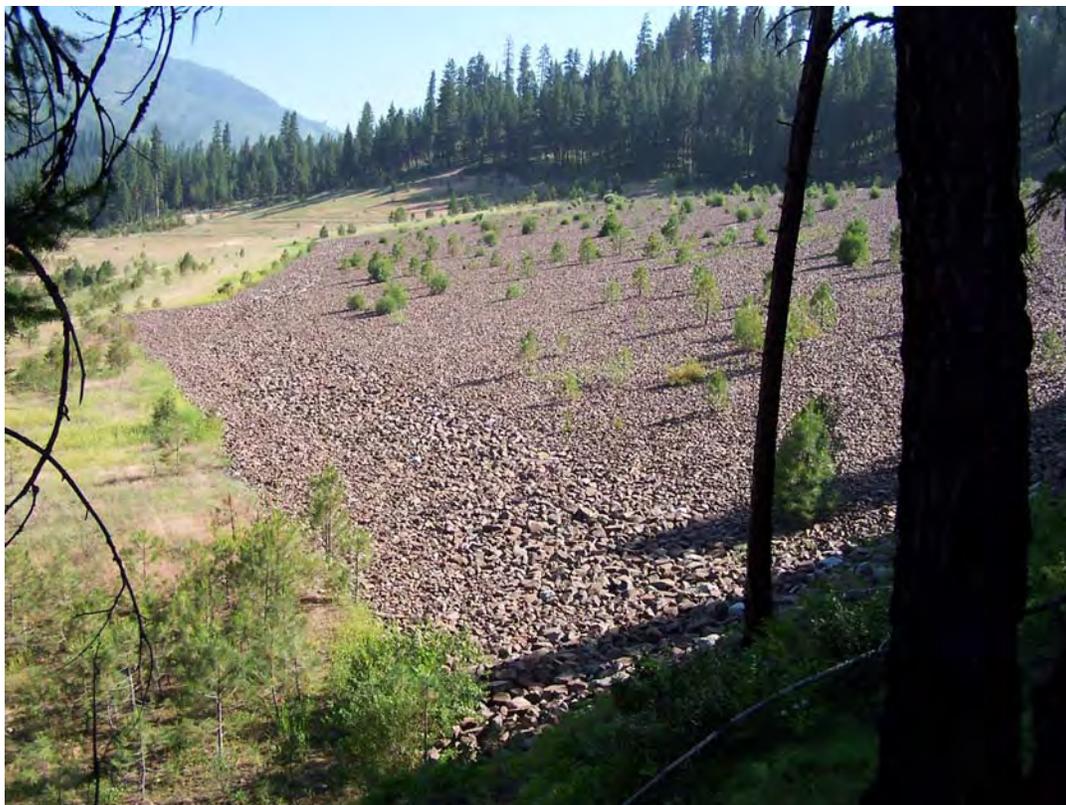
Top and Side Slope of the Disposal Cell—The 8-acre disposal cell was completed in 1991. Basalt riprap armors the top and west-facing side slope of the disposal cell. An apron of larger riprap surrounds the disposal cell on all sides. The riprap was in excellent condition, and no evidence of instability, such as subsidence, slumping, or cracking, was observed on any of the cell surfaces (PL-3).

Vegetation encroachment by species, including ponderosa pine, continues on the top and side slopes of the disposal cell (PL-3 and PL-4). Encroachment is a natural process operating at this location and will be allowed to continue in accordance with the LTSP. Although DOE is no longer required to remove pine trees as they mature, the revised LTSP states that DOE will repair any damage that may occur to the riprap cover and underlying cover layers caused by blowdown or other processes to maintain protection from erosion and possible consequent dispersion of cell contents. The largest ponderosa pine trees on the cover are now approximately 9 feet tall.

LOW 7/2008. PL-3. West slope of the disposal cell.

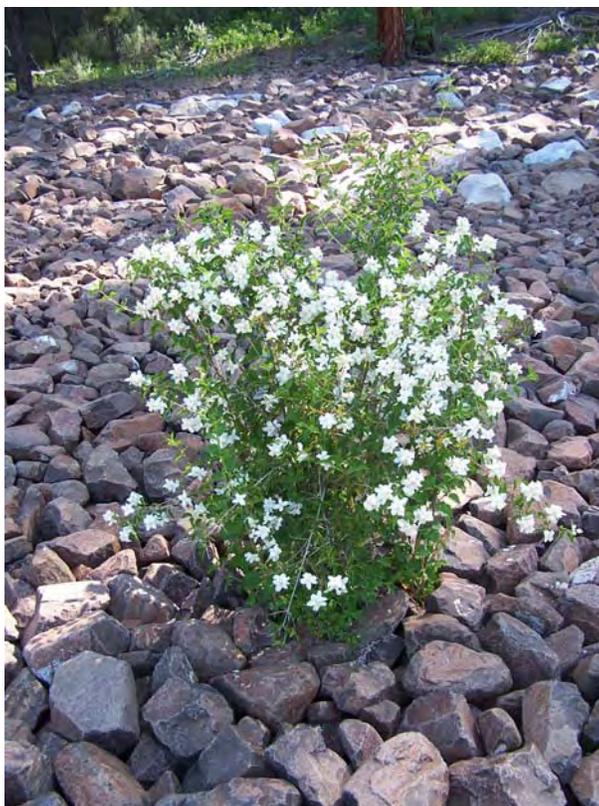
LOW 7/2008. PL-4. Lewis' mock orange growing on the disposal cell cover.

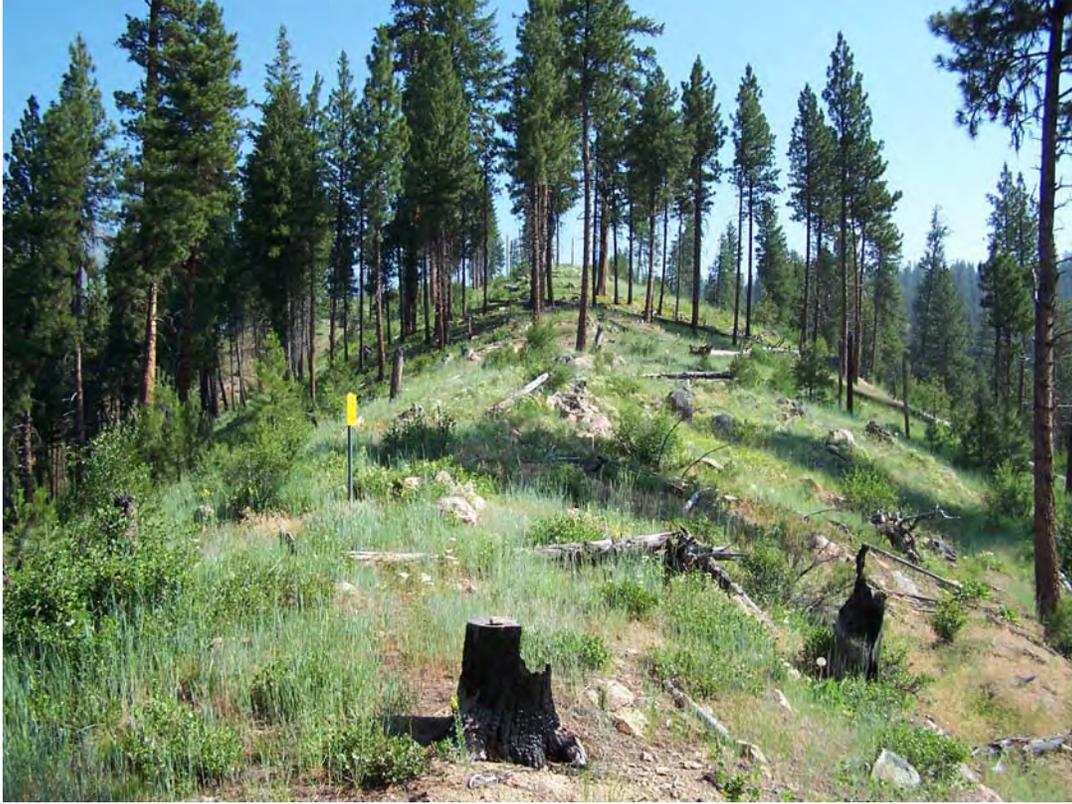
Area Between the Disposal Cell and the Site Boundary—The steep slopes east (PL–5) and south of the site are stable and vegetated with well-established grasses and ponderosa pine trees. One active erosion rill was previously discovered along the north boundary of the site adjacent to perimeter signs P5 and P6; it had eroded through the berms of the lower two interceptor benches. The breach in Interceptor Bench 1 was repaired in October 2004, and the breach in Interceptor Bench 2 was repaired in June 2005. Both repairs were in excellent condition.

LOW 7/2008. PL-5. View north of the ridge along the east side of the site.

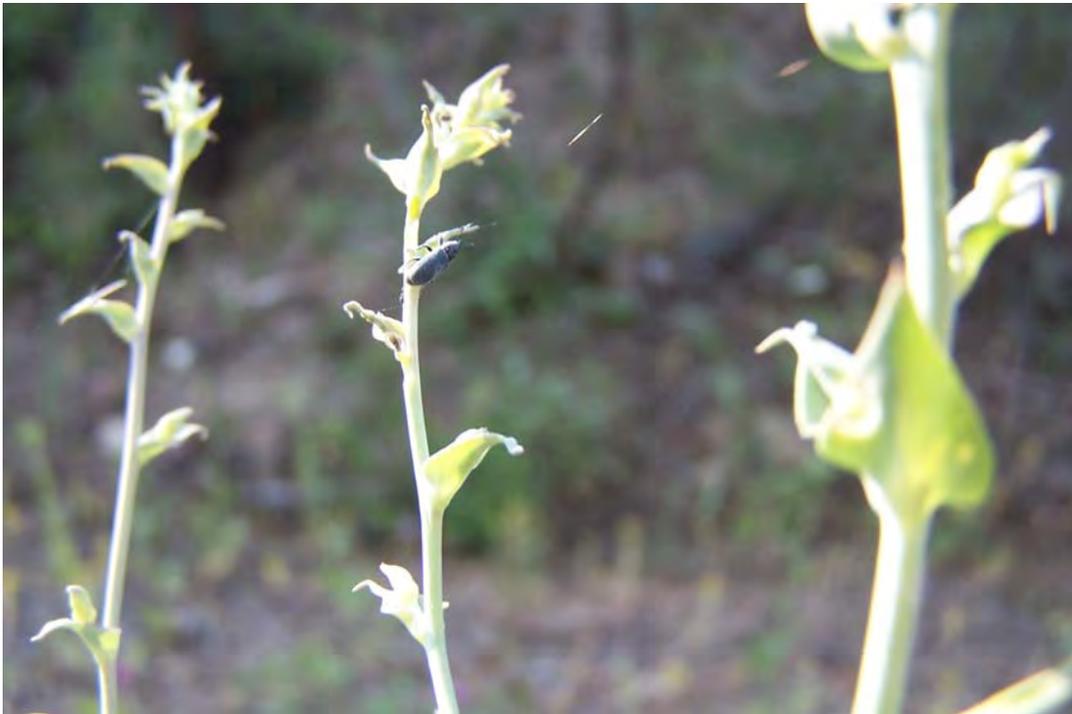
10A Infestations of state-listed noxious weeds continue to persist on and adjacent to the site. Dalmatian toadflax, spotted knapweed, and Canada thistle have been treated with herbicide twice a year since summer 2003, and their populations have decreased significantly. In 2008, DOE purchased several cartons of *Mecinus janthinus*, a stem-boring weevil that specifically targets Dalmatian toadflax, and released them at two locations on the ridge east of the disposal cell. Inspectors observed many of these insects on toadflax plants (PL–6). Because of the presence of these insects, Dalmatian toadflax will no longer be treated with herbicide.

LOW 7/2008. PL-6. Mecinus janthinus weevil on a Dalmatian toadflax plant.
